**CHARACTERIZATION OF EARTHEN ARCHITECTURAL SURFACE
FINISHES FROM KIVA Q,
CLIFF PALACE, MESA VERDE NATIONAL PARK
COLORADO**

A THESIS

Historic Preservation

1999

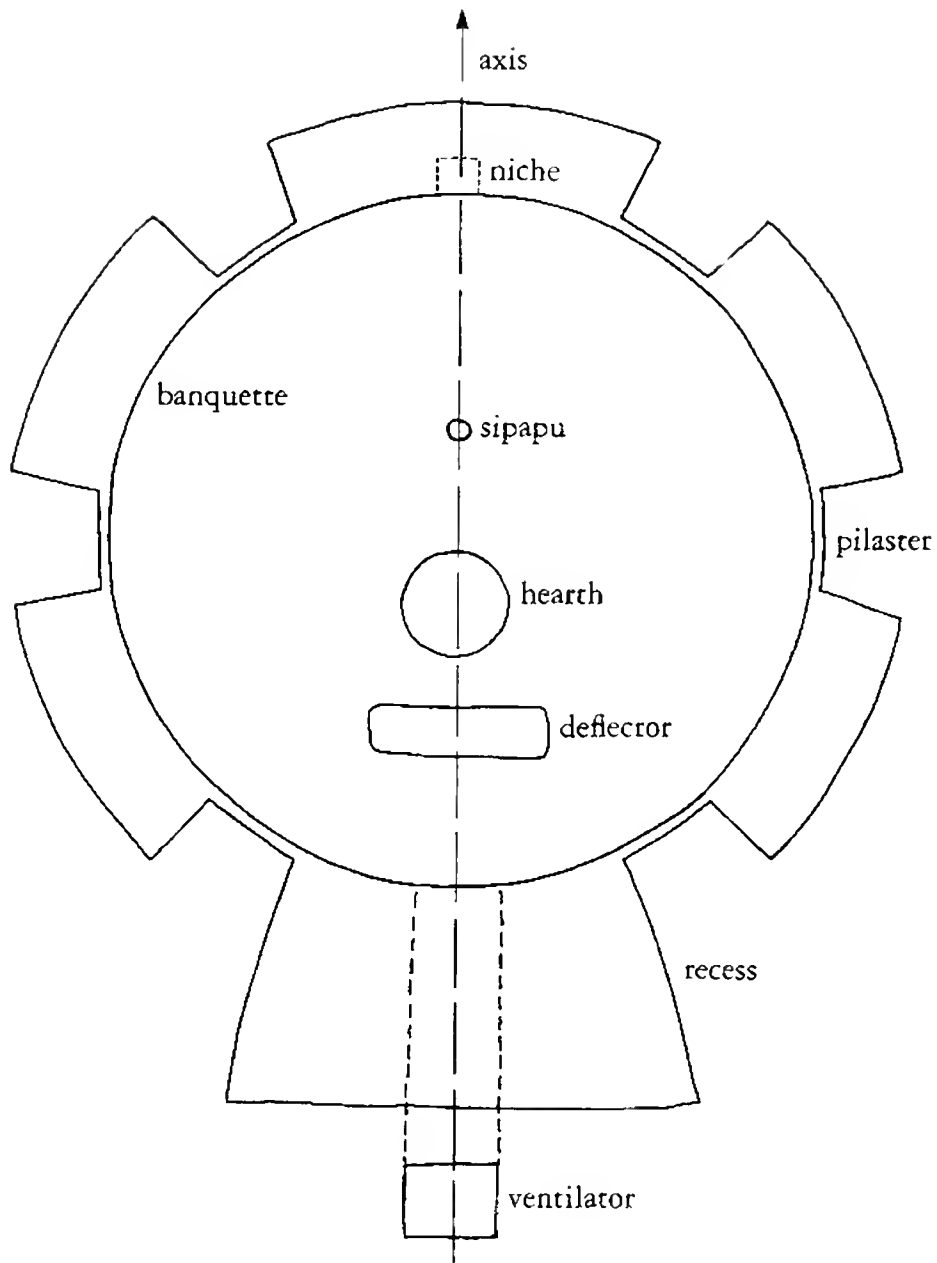
Figure 7. Typical Mesa Verde kiva plan. From William M. Ferguson and Arthur H. Rohn, *Anasazi Ruins of the Southwest in Color* (Albuquerque: University of New Mexico Press, 1987), p. 29.

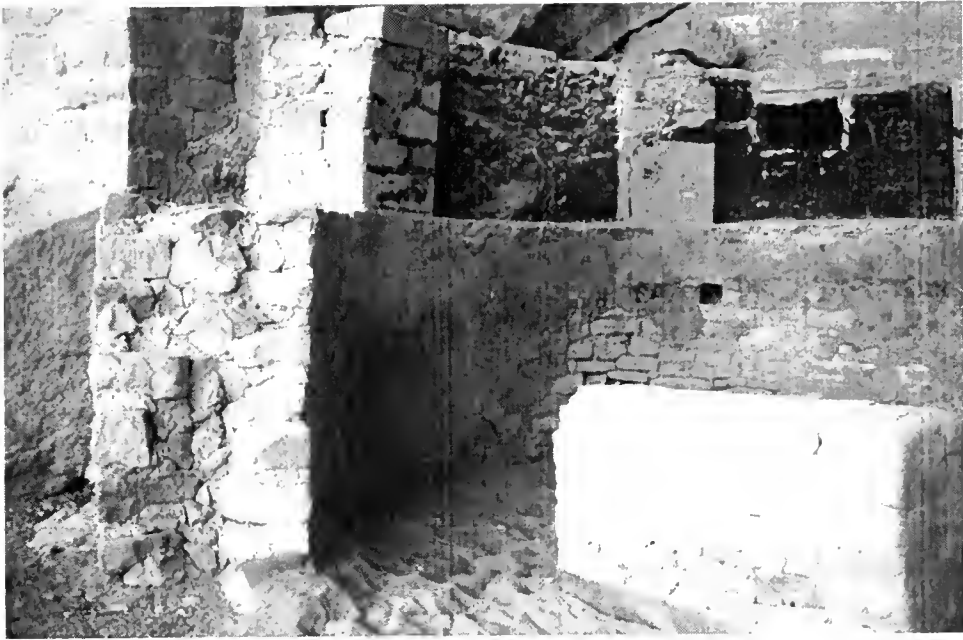
Figure 12. Kiva Q, north wall, deflector.

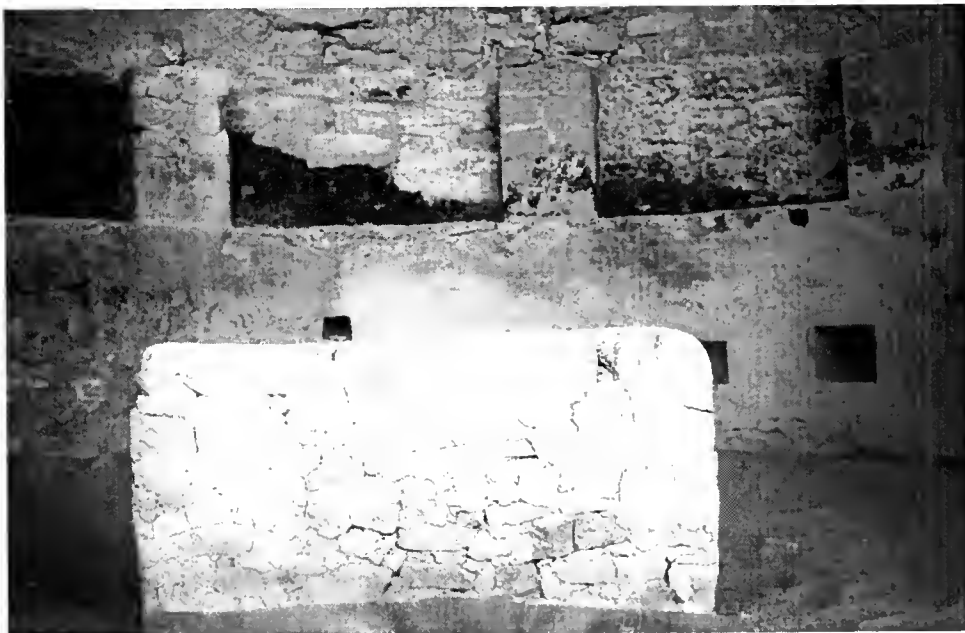
Figure 13. Kiva Q, east wall, deflector.
